Manhole Inspection Summary

Manhole # S33C__014MH

Insp Date: **8/27/09 9:28 AM**

Location Address: **219 W MULBERRY ST**

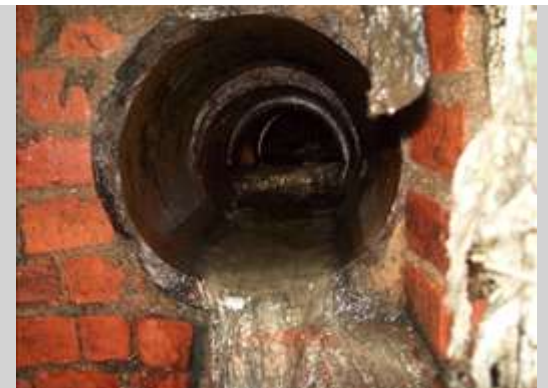
4 O'Clock Inflow

10 in. Circular Gravity Sewer
Pipe In @ 4 O'Clock

Pipe Material: **Clay** ☐ Pipe Lined

Infiltration: **None**
